Neptune Apex EB832 12v MeanWell Upgrade/Repair

This repair applies to older Neptune Apex EB832's with Step Down 500ma DC Modules and ALL the following symptoms:

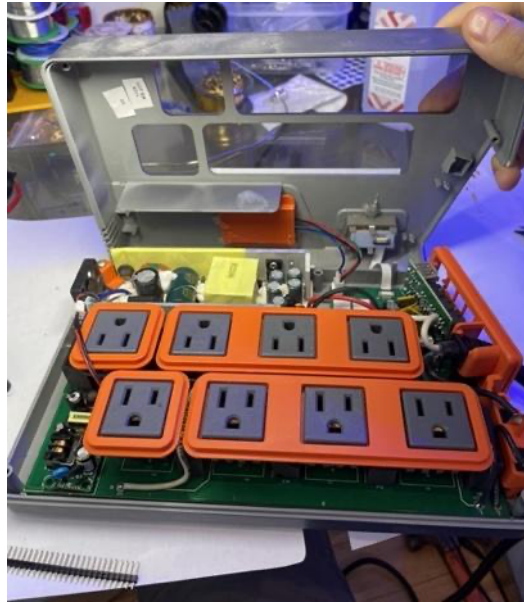
1. Ensure EB832 is unplugged for at least 5 minutes. Remove 3 Phillips screws from the back of EB832, then flip over and fold open EB832 as shown. **Be careful to not damage the LED indicator ribbon cable. You can leave it attached during this repair.**

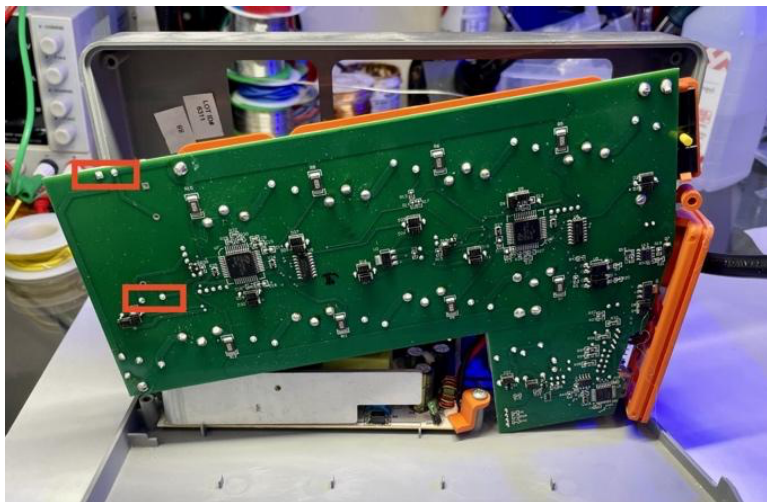
2. Fold up the main PCB to access the back, while being careful to not damage the LED indicator ribbon cable. There is one orange PCB hold-downs that may require loosening and rotating to release the PCB. Highlighted are 4 pins that require desoldering.

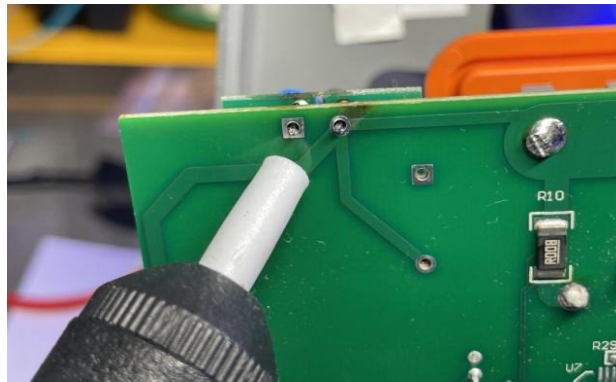
3. Desolder the 4 pins, and then pull off 12v power supply. Below image is after using [solder sucker tool \(Amazon, \\$6.99\)](#), which makes the job easier. All solder MUST be removed to fit new MeanWell PSU. If you are having trouble desoldering the pins, watch [youtube videos about desoldering](#). Essentially, use flux and apply some fresh solder if you have any trouble.

After the PSU is removed, verify hole is clean of solder and the new header pins will be able to slide in easily. If you leave solder in the holes and cannot fully insert the new header pins, it is a **FIRE HAZARD** (Example on last page).

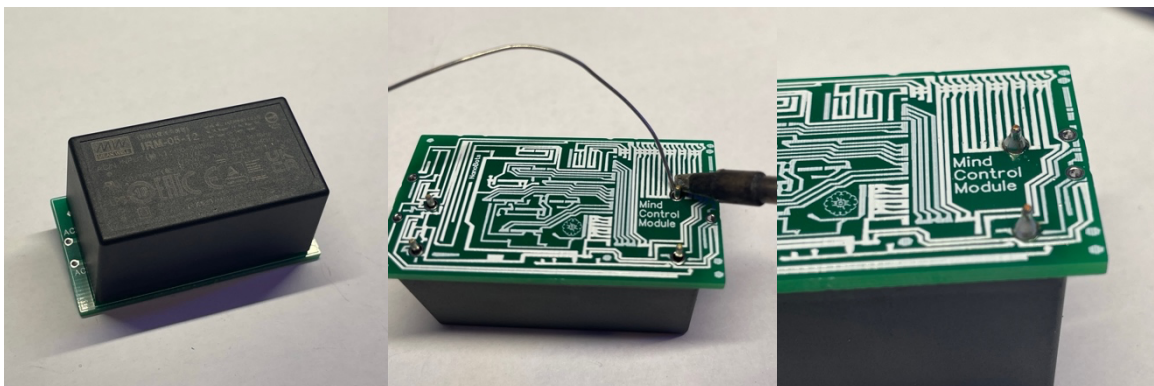
4. If you have “Meanwell Upgrade KIT”, preassemble the PSU as follows. If you have the “Meanwell Upgrade Assembled” skip to step #5 .
 - 4.1. Place Meanwell PSU onto PCB. Flip over and solder all 4 pins. Make sure solder joint looks nice and round, fully covering the pin and pad.

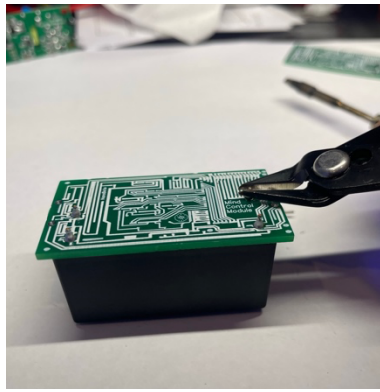
- 4.2. Cut off tip of pin to shorten it slightly and prevent it from contacting the EB832 main PCB. Do NOT cut it flush to the PCB; just cut off the top 1mm of pin.

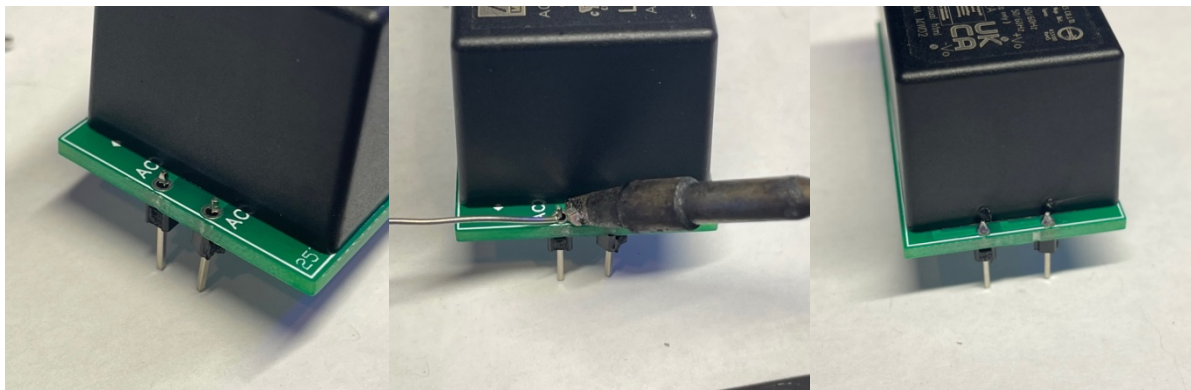
- 4.3.** Break apart your 4 headers and place them underneath the PCB as shown. The short end will be facing up. Try to get these as straight as possible so they go into the EB832 easily later. Solder the joints and ensure the joint covers the pin and pad.

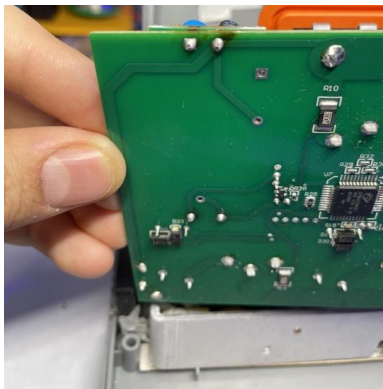
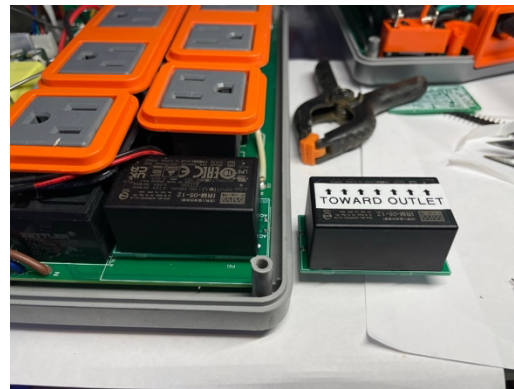
5. Put replacement Meanwell PSU in place with the “AC” labels facing on the outside edge of the EB832. Solder the pins in place. If the pins are not fitting in well, double check you have the correct side facing inward (shown below) and pins are not bent. Ensure the pins come fully through the board and you have a nice bead of solder.

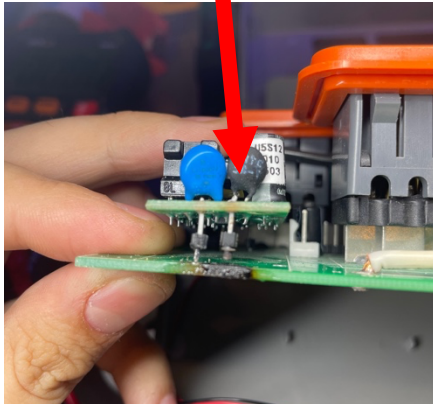
WARNING: IF THE PINS ARE NOT FULLY INSERTED THROUGH THE BOARD AND A NICE SOLDER BEAD PRESENT, IT CAN PRESENT A FIRE HAZARD. HERE IS AN EXAMPLE OF SOMEONES POOR SOLDERING ATTEMPT THAT LED TO BURNING:

Pin was not through board during soldering.

This pin did not go fully through the board during soldering, and barely made contact. Fire risk.

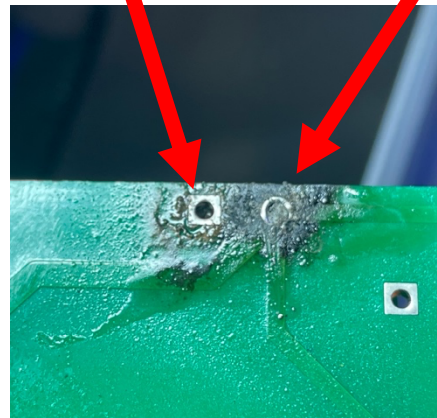
Solder did not reach this pin, which arced out, smoked, and came close to a fire.
